# Manhole Inspection Summary

Manhole # S11EE\_008MH

**Location** Address: **REAR OF 3022 BELMONT AVE** Cross Street: **LONGWOOD ST**

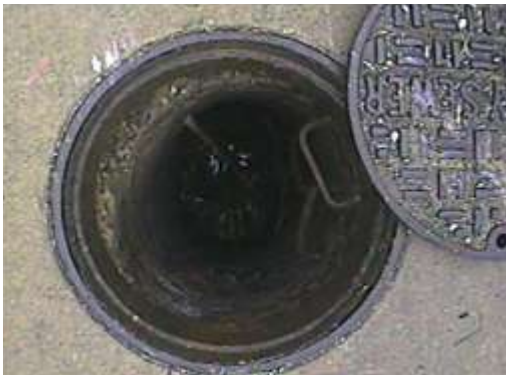
Defect 5

**Frame** Offset: **1** (in.) Condition: ☒ Sound ☐ Cracked ☐ Leaks

FRAME OFFSET

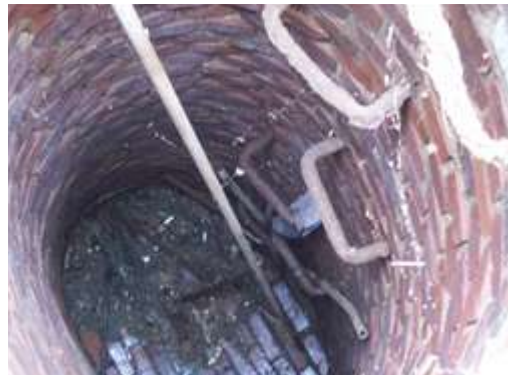
Defect 4

**Surcharge** ☒ **Evidence Of Surcharge** Depth: **5** (ft.) ☐ Active Surcharge Present

EVIDENCE OF SURCHARGE ON 4TH STEP

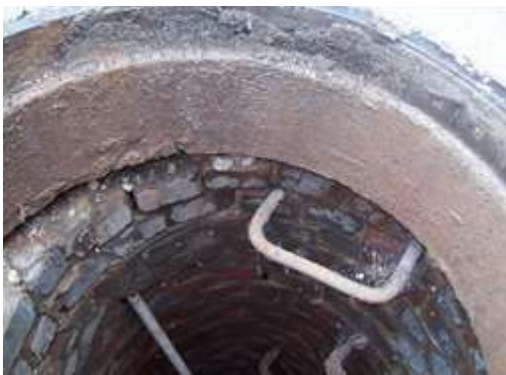
Defect 3

Condition: ☐ Sound ☒ **Cracked** ☒ **Root Intrusion** ☐ Loose Brick ☐ Deteriorated

CRACKED CORBEL, ROOT INTRUSION

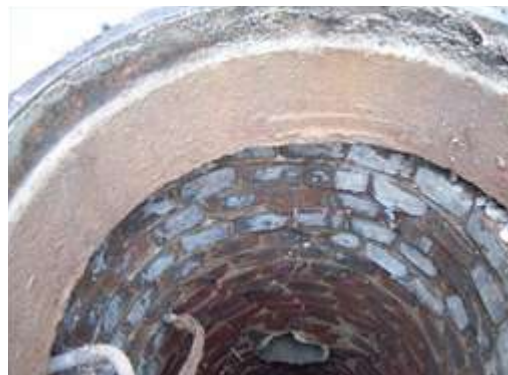
Defect 2

**Steps** Count: **7** Missing: **0** ☒ **Corroded**

CORRODED STEPS

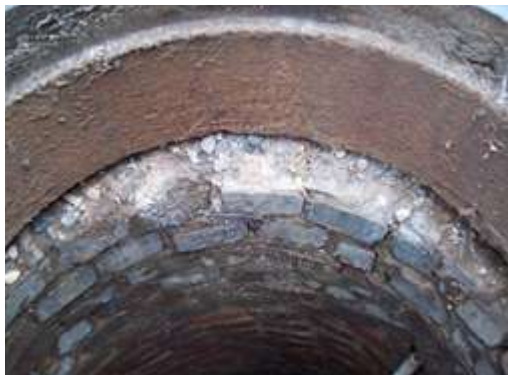
### Defect 1

Condition: ☐ Sound ☒ **Cracked** ☐ Root Intrusion ☐ Loose Brick ☐ Deteriorated

CRACKED FRAME ADJUSTMENT

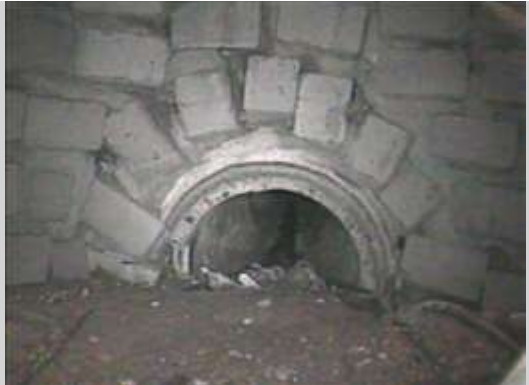
12 O'Clock Outflow

8 in. Circular Gravity Sewer  
Pipe Out @ 12 O'Clock

Pipe Height: (in.) Direct  
Pipe Material: **Clay** ☐ Pipe Lined  
Invert Depth: **12.75** (ft.) Flow Characteristics: **None**  
Deposits: ☐ None ☐ Mud ☐ Sludge ☒ **Debris** ☐ Grease  
Silt Depth: **3** (in.) Deposits Extent: **Medium**  
Infiltration: **None** Pipe Seal Cond: **Sound**

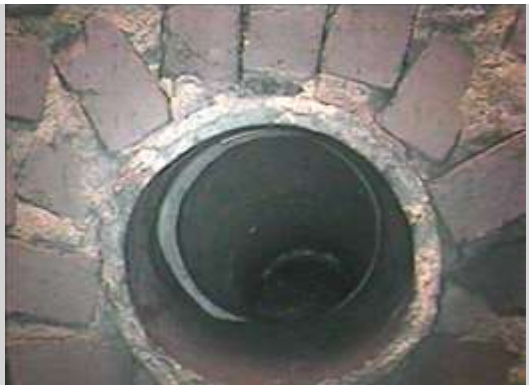
6 O'Clock Outflow

Comments **2 WAY TERMINAL-DOES NOT APPEAR TO BE ANY FLOW IN @ 6 O'CLOCK - GRADE OF PIPE APPEARS TO FLOW OUT OF MANHOLE**

8 in. Circular Gravity Sewer  
Pipe In @ 6 O'Clock

Pipe Height: (in.) Direct  
Pipe Material: **Clay** ☐ Pipe Lined  
Invert Depth: **4.80** (ft.) Flow Characteristics: **None**  
Deposits: ☒ **None** ☐ Mud ☐ Sludge ☐ Debris ☐ Grease  
Silt Depth: (in.) Deposits Extent:  
Infiltration: **None** Pipe Seal Cond: **Sound**
